1. REPORT DATE (DD-MM-YYYY) 03/26/2004		2. REPORT TYPE Technical Paper		3. DATES COVERED (From - To)	
4. TITLE AND SUBTITLE Small Intercontinental Ballistic Missile (SICBM) Rocket Motor Sympathetic Detonation Study				5a. CONTRACT NUMBER	
				5b. GRANT NUMBER	
				5c. PROGRAM ELEMENT NUMBER

13. SUPPLEMENTARY NOTES 31 st Department of Defense Explosives Safety Seminar San Antonio, TX, 24-26 August 2004					
14. ABSTRACT					
20040511 057

Small Intercontinental Ballistic Missile (SICBM) Rocket Motor Sympathetic Detonation Study

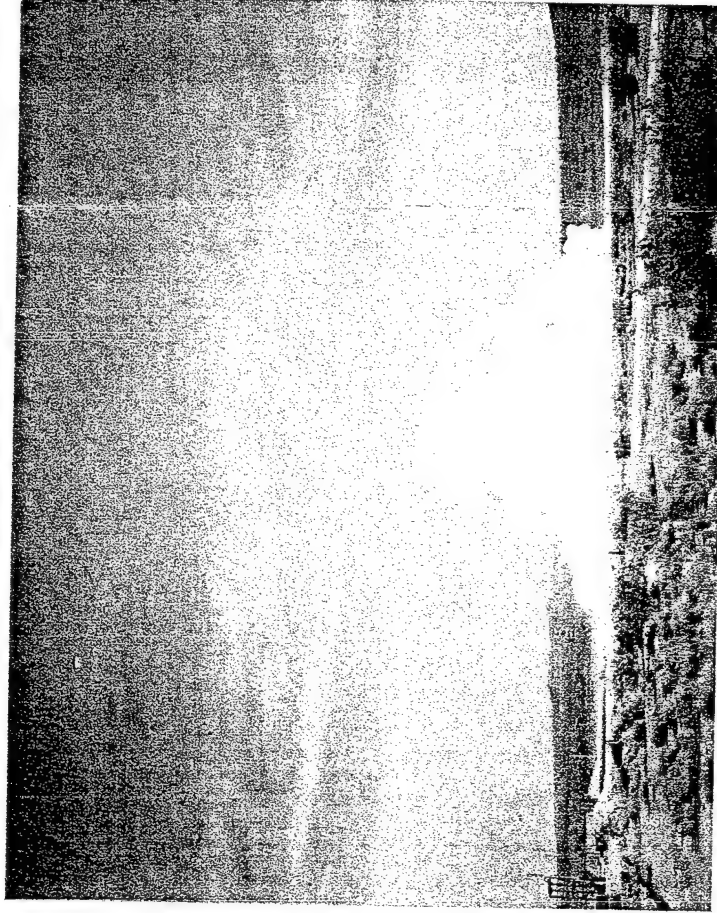
Ground Zero Observations

- Detonation Created a Crater 65 Feet Across and Approximately 15 Feet Deep
- The Stage 3 Motor Sympathetically Detonated
- All the Fragment Catchers & Screens Were Destroyed by the Detonation and Shock Wave
- No readily visible case fibers from the sides of the Stage 1 motor could be found
- A layer of carbon fiber weave material from the motor skirt showed a clean separation of the carbon fibers from the composite matrix material
